Inspection Report

PROPERTY INSPECTION REPORT

Houston TX, 77057

5/17/2018

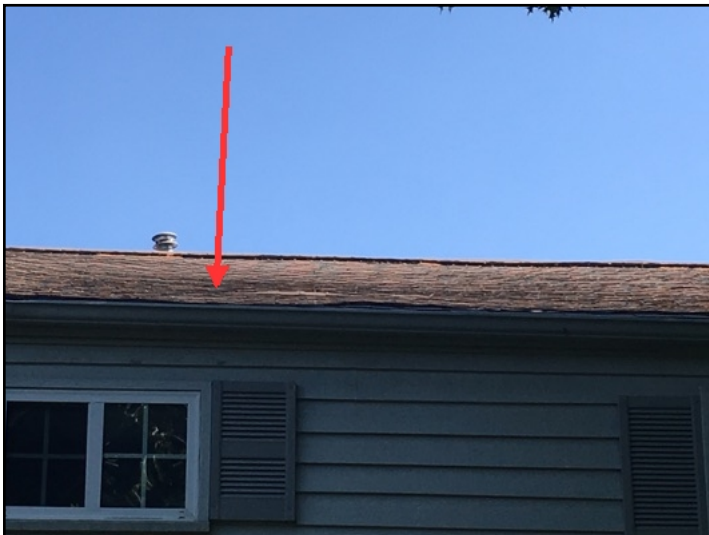
- Roof deflection noted on the front side and back side of the roof. Roof structure framing in the attic was poorly braced to current standards causing the roof to deflect in these areas. Current standards require purlin beams be dimensioned the same size as the rafters and for knee braces to be installed on 4-foot centers.

Roof deflection on the front side of the roof

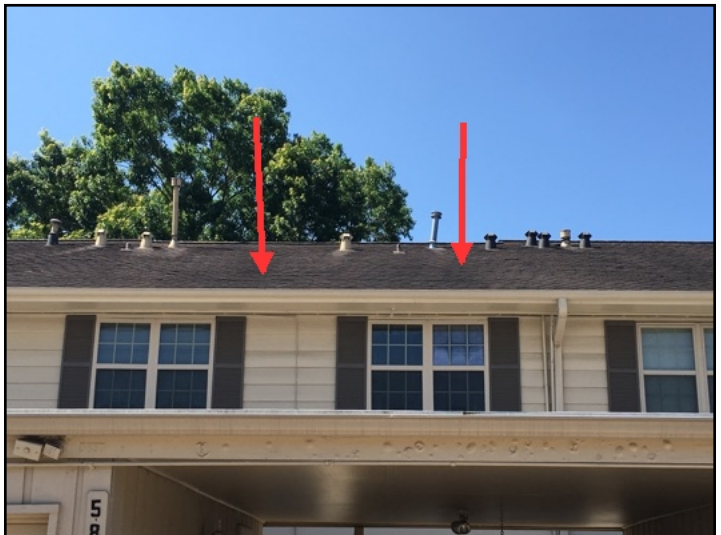
Roof deflection on the back side of the roof

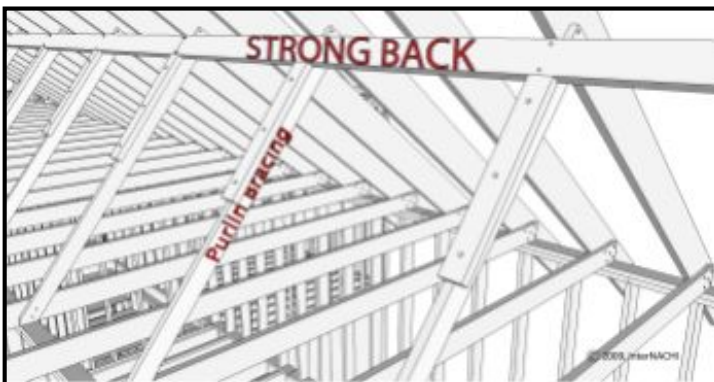
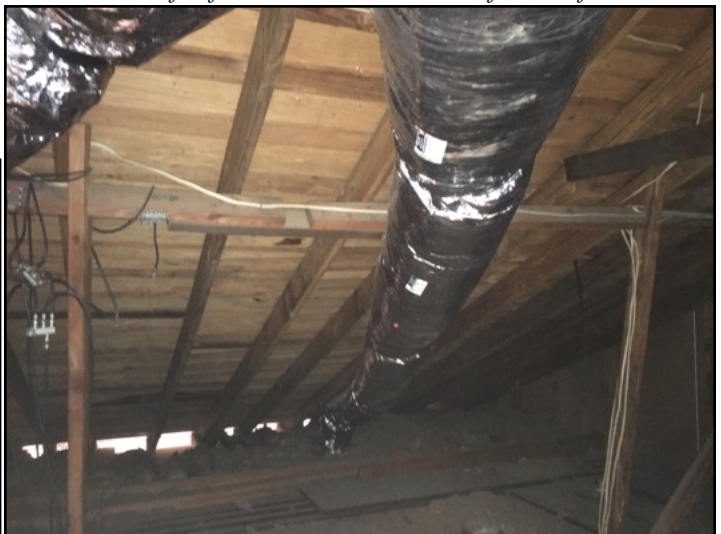
Inadequate purlin bracing

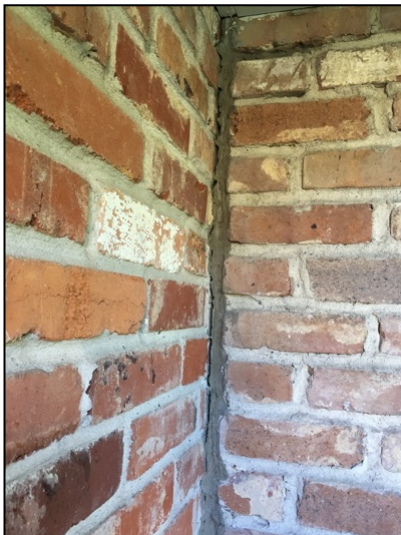
- Indications of mortar patching at the front right and front left corners of the home. Appeared there may have been movement between the brick veneer walls at both corners.
- Observed minor wall cracks above the entryway door which is caused by slight movement or expansion/contraction of the framing. Appeared to be primarily a cosmetic concern.
- Observed stains/corrosion on the interior walls of the upstairs hallway closet. Recommend consulting the owner for more information.
- The drywall was not properly sealed under the upstairs bathroom sink where the water supply lines penetrate the drywall; recommend repair.

Mortar patch at the front right corner

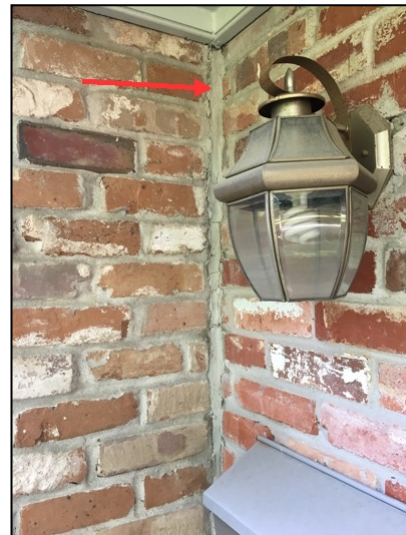
Mortar patch at the front left corner

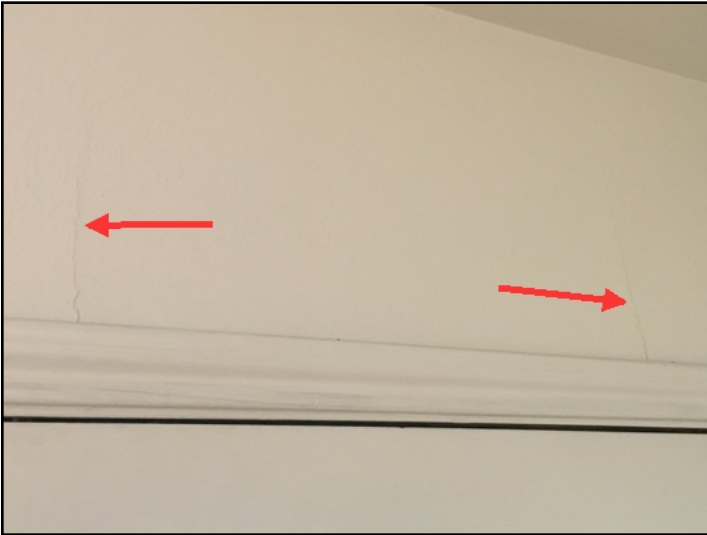
Wall cracks above the entryway door

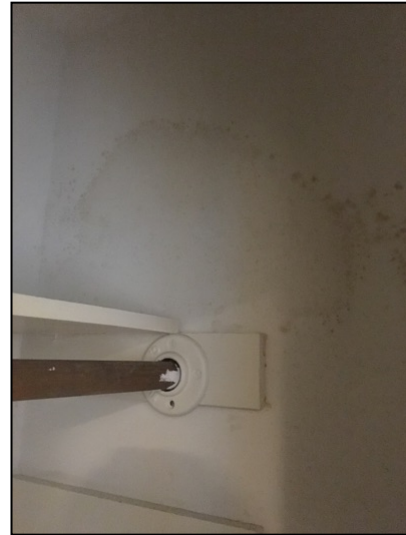
Observed stains/corrosion on the interior walls of the upstairs hallway closet

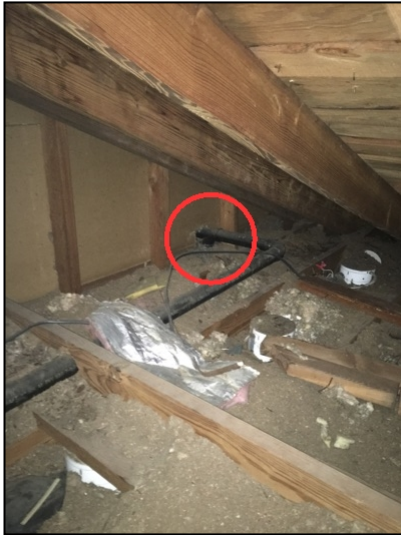
• Observed areas where there was a break/penetration of the firewall in the attic. According to current standards there should be a 1 hour-rated firewall between adjacent townhomes. There was also no parapet on the back side of the roof to provide a firewall at the roof level. Recommend review by a qualified contractor to provide proper firewall protection for the townhome.

Penetration of the firewall between townhomes

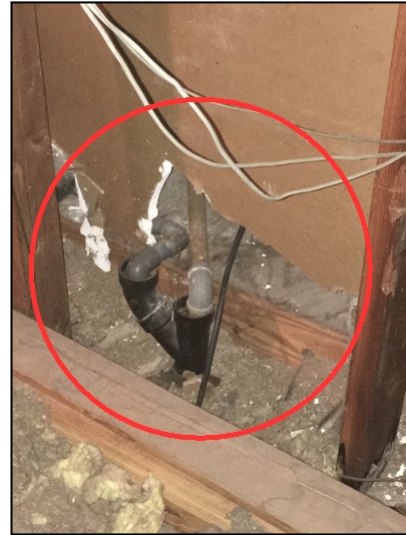
No firewall protection between townhomes

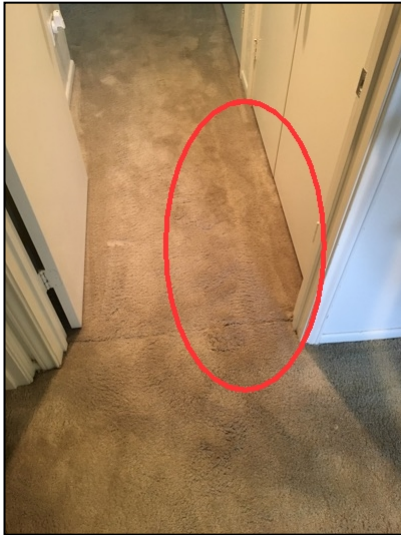
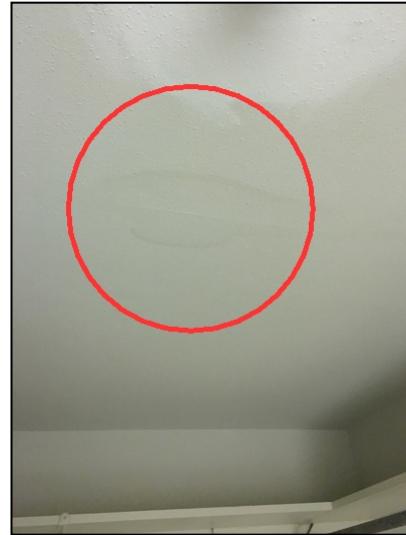
- Observed the floor heaving at the entrance to the master bedroom.
- Observed a dry stain on the ceiling in the master bedroom closet. The inspector probed the stain with a General Pinless LCD Moisture Meter, which showed no moisture present at time of inspection. The ceiling had also been painted, which can hide previous water stains, cracks, or evidence of repairs. Client is advised to review sellers disclosure for additional information.

Observed the floor heaving at the entrance to the master bedroom Observed a dry stain on the ceiling in the master bedroom closet

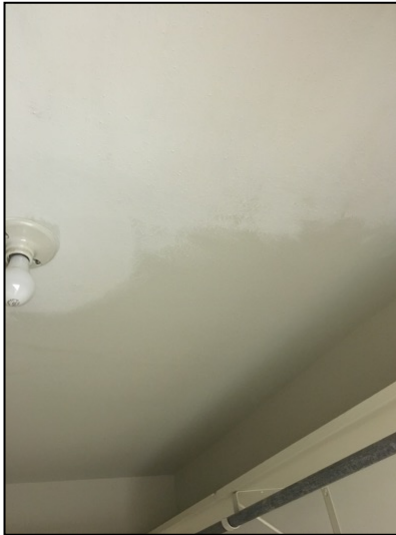
The master bedroom closet ceiling had also been painted, which can hide previous water stains, cracks, or evidence of repairs

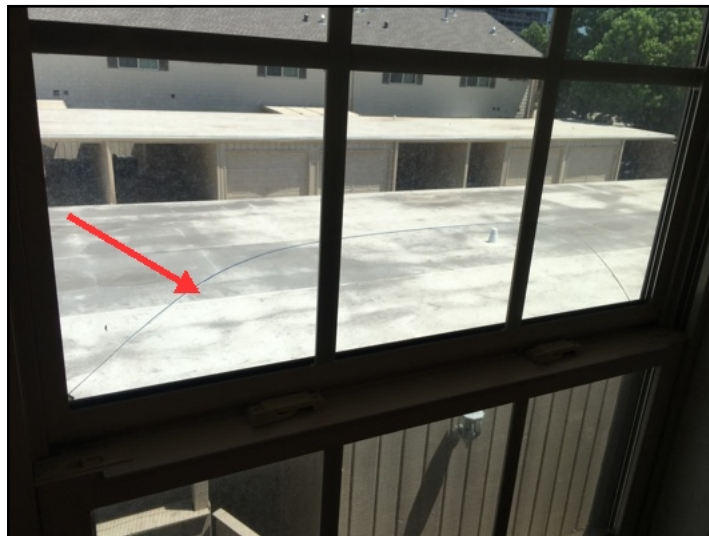
- The upstairs back left bedroom window was cracked; recommend repairs by a qualified glass company for proper operation and safety.

The upstairs back left bedroom window was cracked

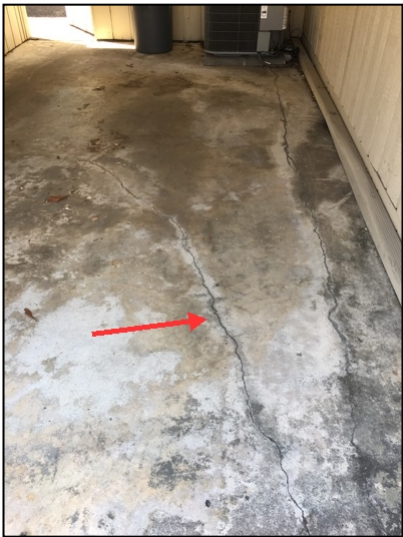
- Minor cracks noted in the carport deck; recommend sealing and monitoring.

Cracks in the carport slab

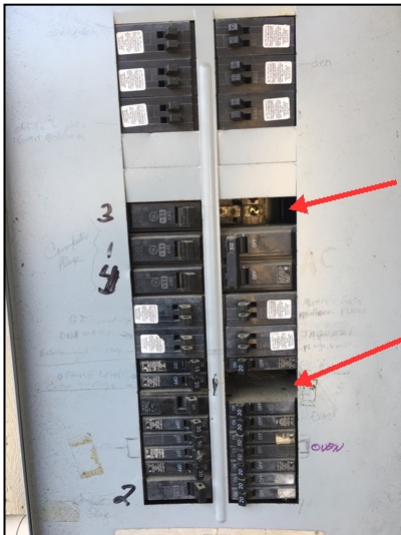
- The main breaker in the main panel was oversized. A #1 AWG Copper wire, which is only rated for a 150-amp breaker, was connected to a 175 -amp breaker. This condition could allow excessive current to be carried by the conductors (wires); recommend review by a licensed electrician.
- Open knockouts and/or exposed busbar observed in both the main panel and sub-panel (behind the refrigerator); recommend installing knockout plugs and/or filler plates as needed, for safety.

Open knockouts and/or exposed busbar observed in the main panel

Recommend review of these issues by a qualified electrician.

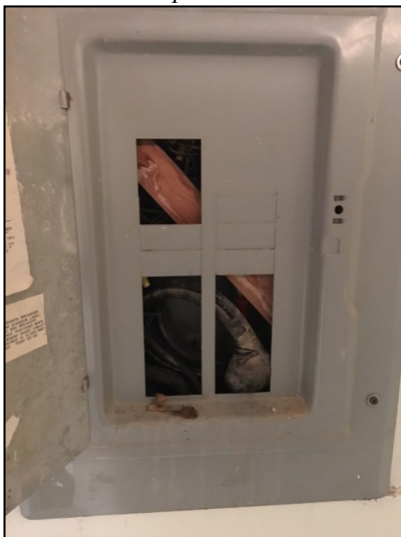
Sub panel behind the refrigerator had open knockouts and exposed cables. This appeared to be a discontinued panel

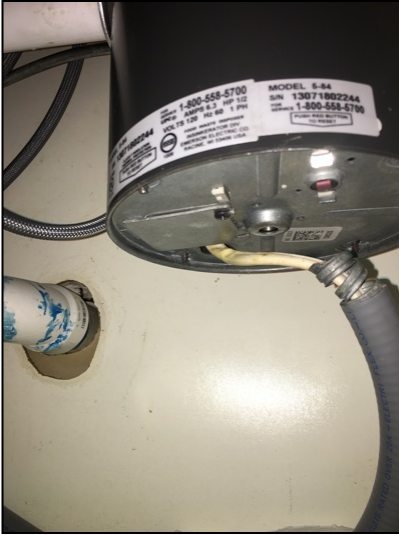
• The waste disposer had no electrical stress connector/strain relief clamp. The vibrations from the unit can cause the cabinet to wear a hole through the insulation of the wire; recommend installing one to ensure safety.

The waste disposer had no electrical stress connector/strain relief clamp

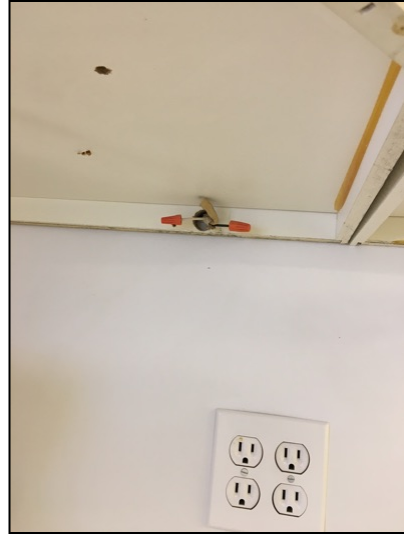
• Open splices or bare wires observed in the kitchen, which is a Safety Concern.

Exposed splice underneath the kitchen cabinet

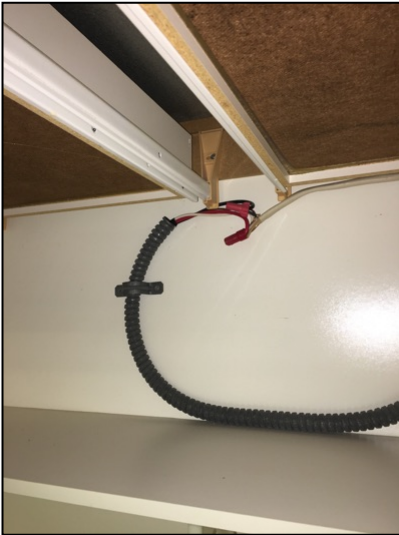
Exposed splice wire for the cooktop

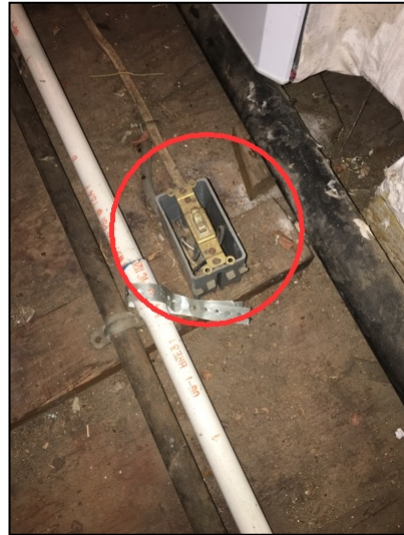
Exposed junction box (furnace switch) for the furnace wiring

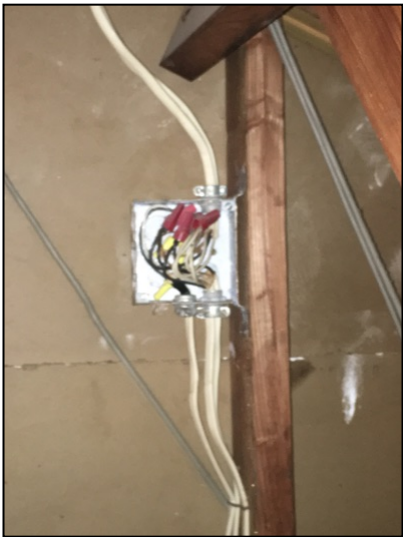
• Open junction boxes observed in the attic. Whenever an electric wire is cut and reconnected, the 'splice' should be encased in a covered junction box to prevent shocks and separation of the splice.

Exposed junction box in the attic

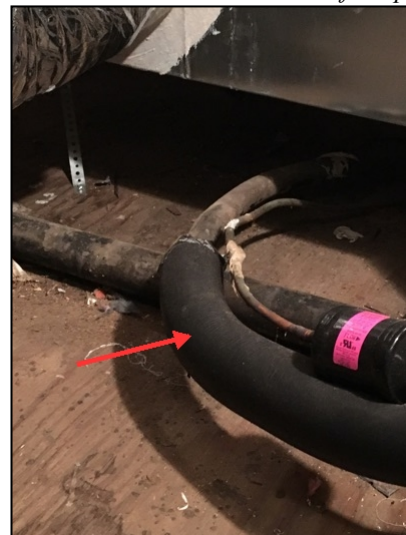
Recommend replacing the old refrigerant line insulation with newer insulation as already installed on a section of refrigerant line near the AC unit in the attic

- Recommend replacing the old refrigerant line insulation with newer insulation for better HVAC efficiency.

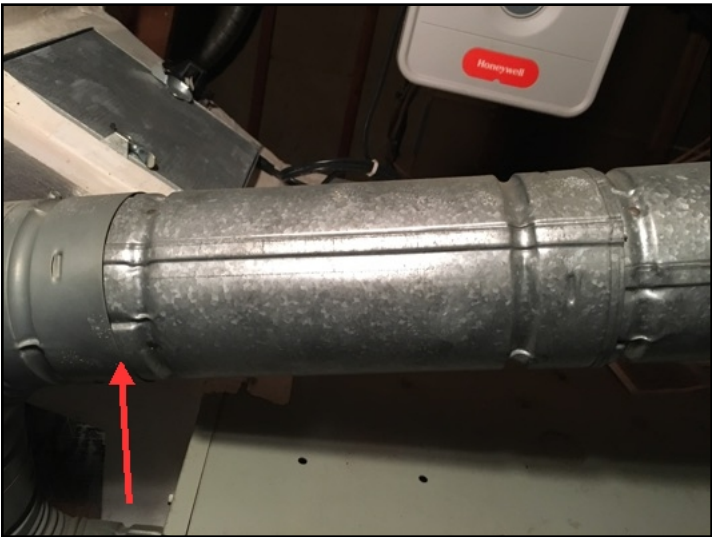
- The flue vent was improperly installed. Starting at the furnace draft hood the flue vent should fit inside each succeeding flue vent section instead of over it. With this installation flue gas could leak out into the attic space. Recommend review by a HVAC contractor.

Furnace flue vent installed incorrectly

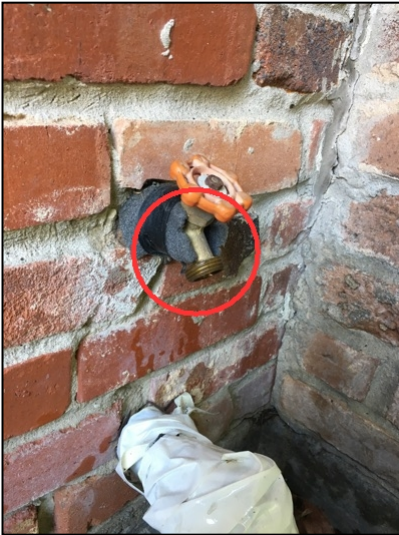
No backflow preventers

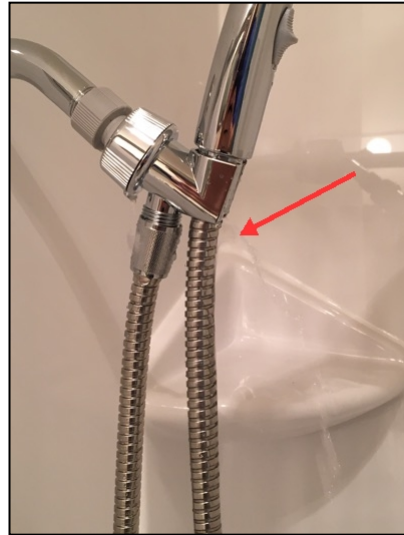
- The shower head in the upstairs bathroom was leaking.

The shower head in the upstairs bathroom was leaking.

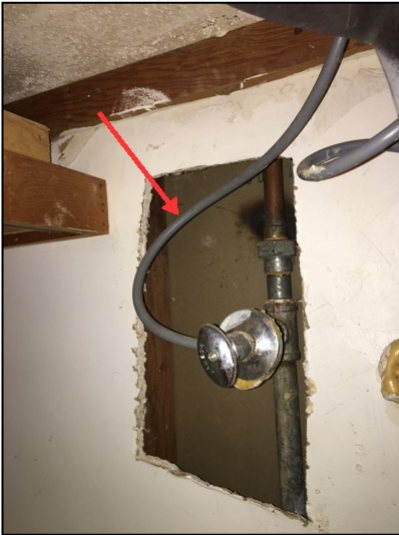
Observed improper material (appeared to be rubber) used for the flexible water line connections in the upstairs bathroom lavatory

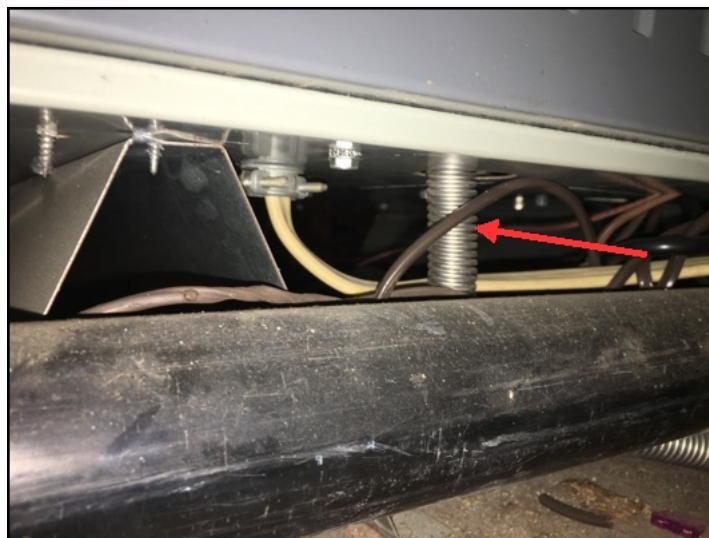
- The flexible gas connection for the furnace passed through the enclosure cabinet. The connector can vibrate against the sharp sheet metal side of the enclosure, which may cause a leak in the gas line; recommend a licensed plumber install black pipe to the exterior of the enclosure, then connect the flex gas line to help prevent possible damage to the gas flex line.

The flexible gas connection for the furnace passed through the enclosure cabinet

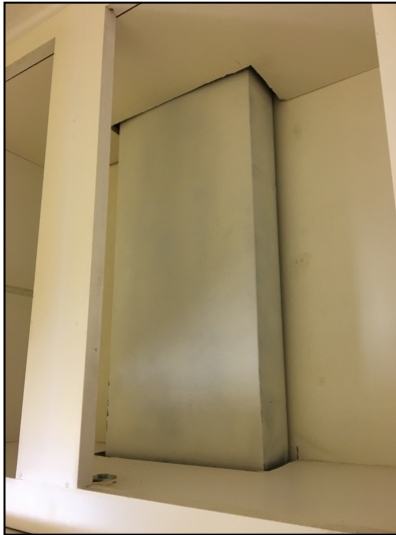
It appeared that the range exhaust vent terminated in the ceiling space above the kitchen

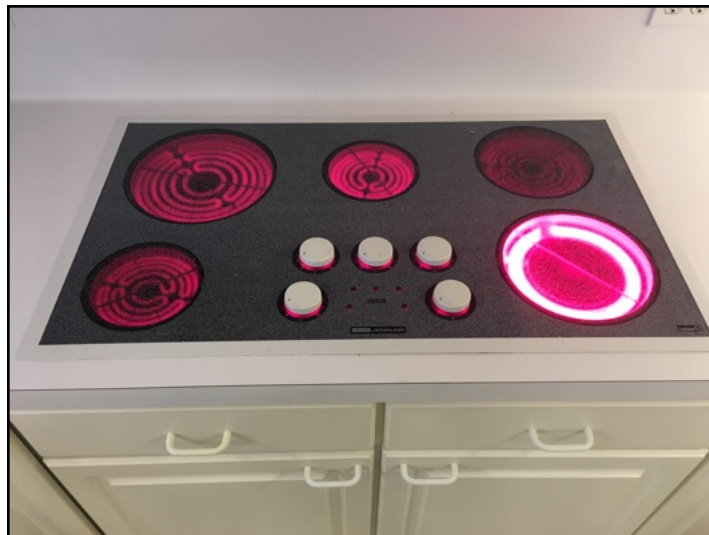
- The upper oven was set to 350°F, the actual temperature was 345 degrees. Within +/- 25 degrees is considered the normal range.
- The front right burner element of the cooktop was not functioning properly.
- The lower oven was not functioning. Recommend review of the cooktop and oven by a qualified appliance contractor.

The front right burner element of the cooktop was not functioning properly.

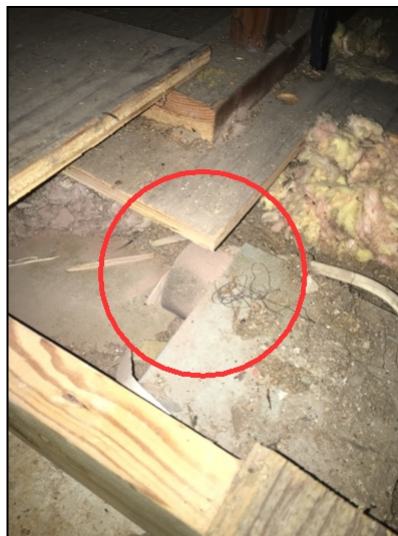
- Both upstairs bathroom exhaust fans were improperly venting to the attic, which allows moist air into the attic. Provision was made for exhaust vents for both fans that terminated through the roof, but both vents had been disconnected.
- The half bathroom exhaust fan vibrated or was excessively noisy. This may indicate a worn armature or bearings.

*Both upstairs bathroom exhaust fans were improperly venting to the attic, which allows moist air into the attic*

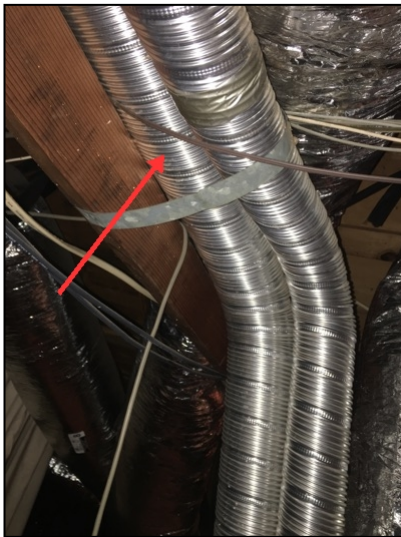
- Only the first 8' (transition duct from the dryer to the interior wall) is allowed to be flex pipe, the remaining length should be smooth wall pipe; recommend replacing offending material with 4" diameter smooth wall pipe from the interior wall to the exterior wall.
- The dryer vent was venting lint into the attic, which is a fire hazard. This could be due to the dryer vent being too long. Recommend review, and if necessary, add a booster fan. Booster fans are no longer allowed in the new codes. The removal of the booster fan from the code is because of a serious fire hazard when not properly maintained. Most manufacturers require the booster fan to be cleaned every six months because lint is highly combustible. If a booster fan is installed, follow the manufacturer guide for cleaning.

*Dryer vent should be hard walled*

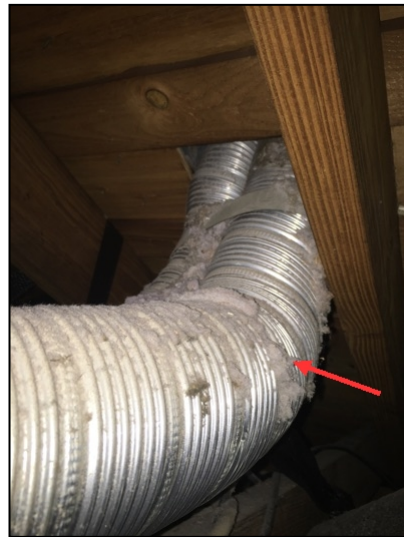
*The dryer vent was venting lint in the attic*
☐ ☒ ☐ ☐
I. Other
